Manhole Inspection Summary

Manhole # S43A2_032MH

Insp Date: **12/12/07 10:21 AM**

Location Address: **1014 E. Patapsco Ave.**

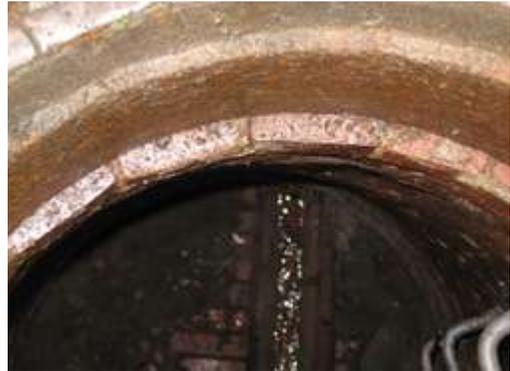
Defect 1

Frame Offset: **1** (in.)

Frame offset

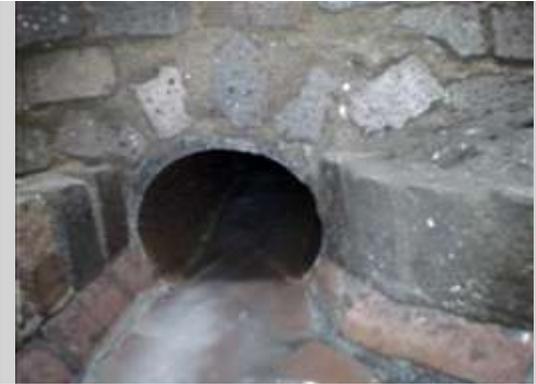
12 O'Clock Outflow

8 in. Circular Gravity Sewer
Pipe Out @ 12 O'Clock

Pipe Height: **7.2** (in.) Rod and Bar (Angled)
Pipe Material: **Clay** Pipe Lined
Invert Depth: **9.68** (ft.) Flow Characteristics: **Fast**
Deposits: None Mud Sludge Debris Grease
Silt Depth: (in.) Deposits Extent:
Infiltration: **None** Pipe Seal Cond: **Sound**

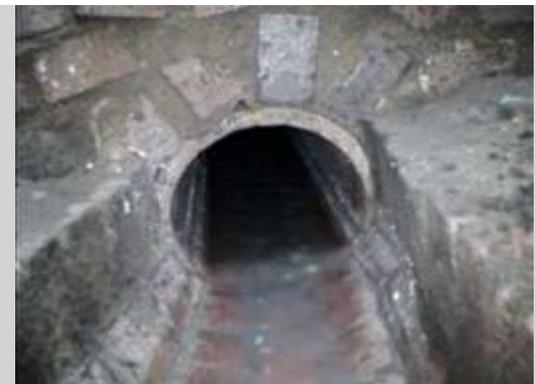
3 O'Clock Inflow

8 in. Circular Gravity Sewer
Pipe In @ 3 O'Clock

Pipe Height: **9.6** (in.) Rod and Bar (Angled)
Pipe Material: **Clay** Pipe Lined
Invert Depth: **9.57** (ft.) Flow Characteristics: **Fast**
Deposits: None Mud Sludge Debris Grease
Silt Depth: (in.) Deposits Extent:
Infiltration: **None** Pipe Seal Cond: **Sound**

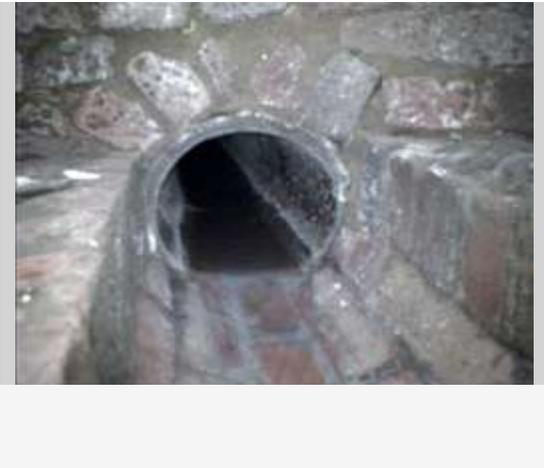
6 O'Clock Inflow

8 in. Circular Gravity Sewer

Pipe In @ 6 O'Clock

Pipe Height: **9.6** (in.) Rod and Bar (Angled)
Pipe Material: **Clay** Pipe Lined
Invert Depth: **9.53** (ft.) Flow Characteristics: **Fast**
Deposits: None Mud Sludge Debris Grease
Silt Depth: (in.) Deposits Extent:
Infiltration: **None** Pipe Seal Cond: **Sound**

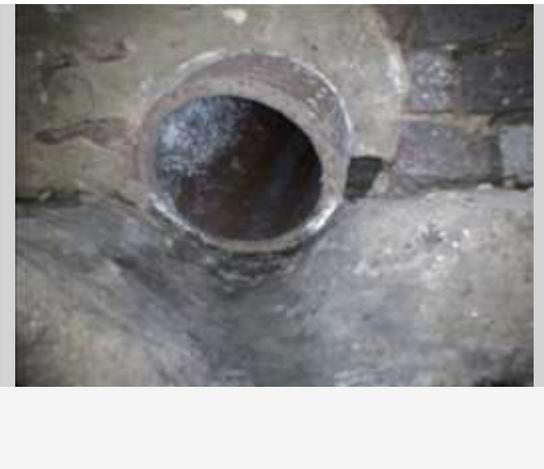
10 O'Clock Inflow

6 in. Circular Gravity Sewer

Pipe In @ 10 O'Clock

Pipe Height: **6** (in.) Rod and Bar (Angled)
Pipe Material: **Clay** Pipe Lined
Invert Depth: **8.91** (ft.) Flow Characteristics: **None**
Deposits: None Mud Sludge Debris Grease
Silt Depth: (in.) Deposits Extent:
Infiltration: **None** Pipe Seal Cond: **Sound**

Connects To: **House connection / Service line**
 Possible Illicit Connection
